November 15-18, 2006 São Paulo – Brazil

## THE USE OF CEMENT FIBRE COMPOSITES IN PROLONGED WET ENVIRONMENTS

BRANKO R BABIC

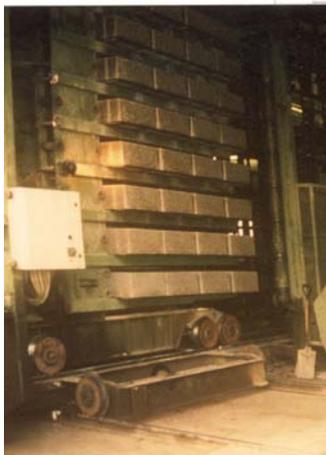
Fig 1

Manufactured StrawCrete building blocks.  
Pat. 2340125.

Initial efforts at manufacturing StrawCrete building blocks approximately fifteen years ago used Crete Grades <sup>2</sup> of wheat straw particles in a 30% by volume ration. Other cellulose concrete mixtures have been in existence for many decades and in the UK, standard sized building blocks manufactured for the medium density concrete block market, used selected imported wood that had been allowed to stand for several months before use. Cellulose additives to concrete impart a warm, delicate, pleasant color to the finished product as well as reducing the weight of the block. Such additives therefore are used for fine faced exposed block construction that, provides a visually pleasing surface which does not need additional surface treatment. These blocks were used for internal applications only and we now have a manufacturer <sup>4</sup> who can make any number of blocks to order. The 440x215x100mm blocks comply with UK Building Regulations.

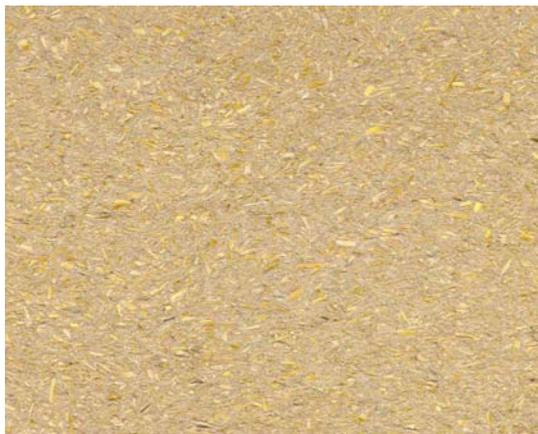
Fig2

Cement wheat straw composite board

Continuing the experiments, sheet material were manufactured that contained up to 80% volume of straw and 20% by volume of high alumina cement. Materials manufactured with such high quantities of cellulose additive were found not to support fires, so that they could be used as fillers that have good insulation properties manifesting thermal conductivity of about  $0.11\text{w/m}^{\circ}\text{K}$ .

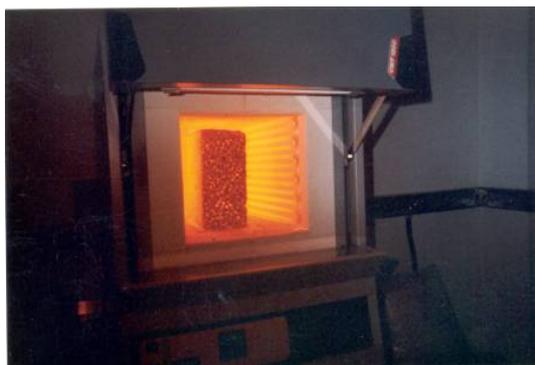
Fig 3

High alumina cement/fibo 440x215x100mm  
 $3.5\text{N/mm}^2$  building block at  $1000^{\circ}\text{C}$  for 24hours.  
Pat. No 2377931

The fire tolerance of these high cellulose and high alumina composites, stimulated interests so that other fire tolerating composites were examined and in the end a composite of high alumina cements as the binder and fibo (a baked clay manufactured material) was used to manufacture a batch (see Fig 3) of building blocks. Other heat tolerating aggregates can be useful e.g. crushed brick, crushed volcanic ash, basalt, clay, fuel ash and other suitable heat tolerating aggregate, to produce fire retardant building blocks that endure heat stress for prolonged periods. Tests in kilns over a 24 hour period at temperatures in excess of  $1000^{\circ}\text{C}$ , showed that the given composites provide suitable fire tolerating building materials that do not collapse in prolonged high intensity fires. The same compositions using prepared grades of fines, provide suitable mortars, renders, plaster board etc to provide an entire system that tolerates fires for prolonged periods and respond to heat stress in a similar way to the prepared blocks. The advantage being that the mortar and block are made from the same material and in any given heat stress situation expand and contract at the same rate.

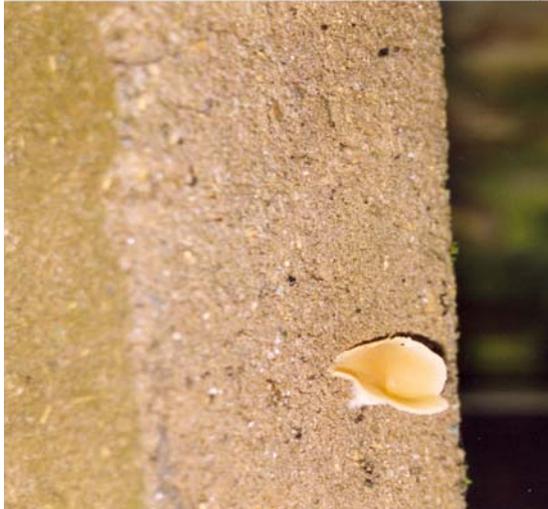
Fig 4

Wood Cement composite building block also grew fungal growth.  
Fungal growths (Peziza Genus)

It was of no surprise to see flora growth on these blocks. The blocks become wet and over the winter months generally remained wet for months on end, with short drying out periods, before the material was again saturated. Several plant forms were observed and of particular interest was the growth of a fungus. This was totally unexpected because although the exposed surface cellulose particulates (being specified at 5mm-0mm) would no doubt attract wood feeding entities, it was expected that these would be of a diminutive size. The appearance of a complex large fungus<sup>8</sup> on the shaded sites of the block, induced an anxiety that certain life forms might have enzyme systems that could actually damage the concrete mixture. These fungal growths remained well contained and short lived and appeared in all cellulose cement bonded composites. The same fungus was seen growing on the wood block but the surprised was the size of the fungus. On closer examination it appeared that the cement, wood, aggregate block used as a control, contained large particles of wood that were 30mm long and up to 5mm thick. The fungus died having consumed the nutrients on which it was growing.

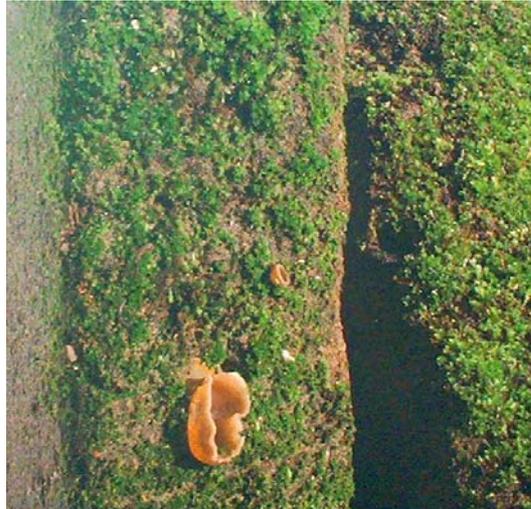
Fig 5

StrawCrete composite building block  
Fungal growths (Peziza Genus)

It appeared clear, that the growth of fungus in cement bonded cellulose composites was dependant on the availability of exposed cellulose, in damp conditions. In all cases, all fungal growth died, as the blocks dried out. Control blocks kept in the dry environment, did not develop or sustain any kind of visible organic life forms during the same time span, nor, did they lose the golden color of wheat straw.

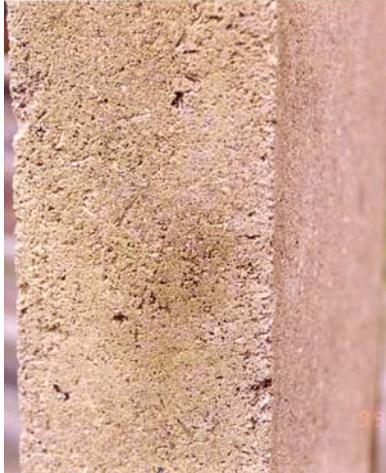
Fig 6

Surface straw particles fall out of the StrawCrete material after prolonged exposure to British weather.

The end result of StrawCrete Blocks being kept in the wet environment for prolonged periods was the loss of all of the surface cellulose particles exposed to the weathering process and a 440 x 215 x 100mm block kept in the wet were seen to show an irregular surface reflecting the shape and form of the surface cellulose particles used in the original mix, see Fig 6.

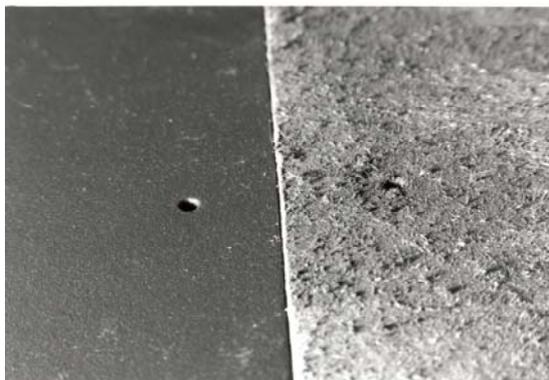
Photograph of a new acrylic coated asbestos cement roofing tile on the left and a ten year old similar tile demonstrating fall out of asbestos from the cementing matrix on the right.

The weathering process is seen right across the cement bonded composite materials industry. As an example, the asbestos fiber cement bonded manufacturing sector has major problems relating to this abrasive process. Work done on wet roofing tiles demonstrates that weathering removes layers of the composites and this occurs extensively. The wet surface containing the fiber is abraded away to release fibers contained therein. Fig 7 shows a ten year old roofing tile on the right of the picture, next to a new tile manufactured by the same manufacturer, demonstrating the extent of the abrasive process which releases fine asbestos fibers into the environment<sup>5,7,9</sup>. Fig 8 demonstrates an old corrugated roofing asbestos cement sheet and clearly shows the asbestos fibers sticking out of the cement matrix. As the weathering process continues, the asbestos fibers loosen from the cementing matrix, to move about in the wind and snap off, to be released into the environment The process of fiber release continues for the life of the asbestos cement product and accelerates with age, so that the older the product the greater the release of asbestos.

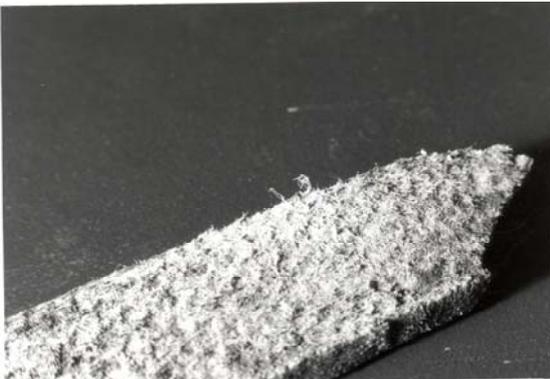
Fig 8

Asbestos cement corrugated sheeting demonstrating fall out of asbestos fiber.

The above mechanism extends to other asbestos fibre products and is clearly seen in cladding sheets, guttering, coving and the many other cement bonded materials manufactured.

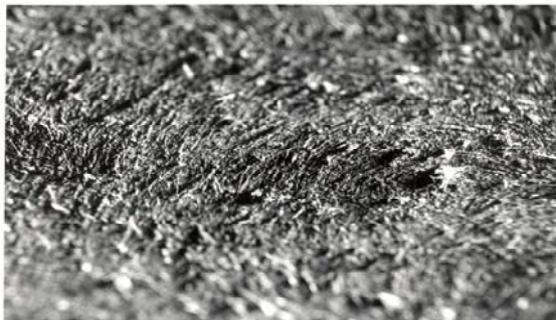
Fig 9

Asbestos cement cladding demonstrating asbestos fibre fallout in old materials

In all cases, fibers are released from cement fibre composites the dropout of fibre being related to the wetting and mechanical abrasive process imposed on the composites. In dry conditions, cement fibre composites retain their composition and fibers such as straw kept in dry conditions are documented to retain their structure for thousands of years. It is the wetting of such materials that causes the problems.

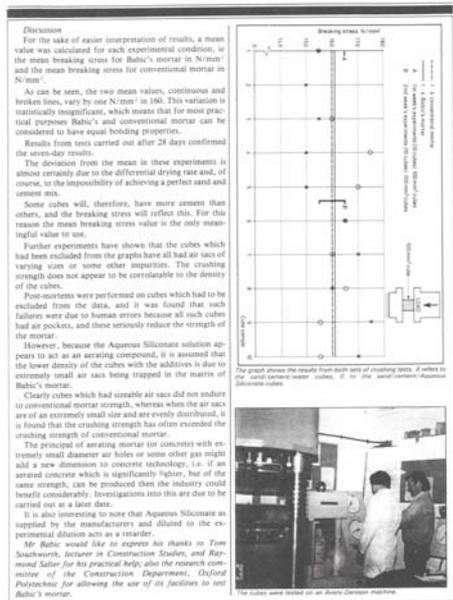
Fig 10

Aqueous Siliconate mortar cubes being crush tested 1982.

After much searching one of the few water soluble chemical DPC preparations, the potassium methysiliconate <sup>3</sup>, that Imperial Chemical Industries were manufacturing at the time, was selected and on mixing the preparation with the mortar, found that the prepared mortar behaved like conventional mortar. All initial results were promising and when the crushing strength data

came back and showed no difference between the aqueous silicate and conventional mortar mixes, the concept was subjected to further testing.

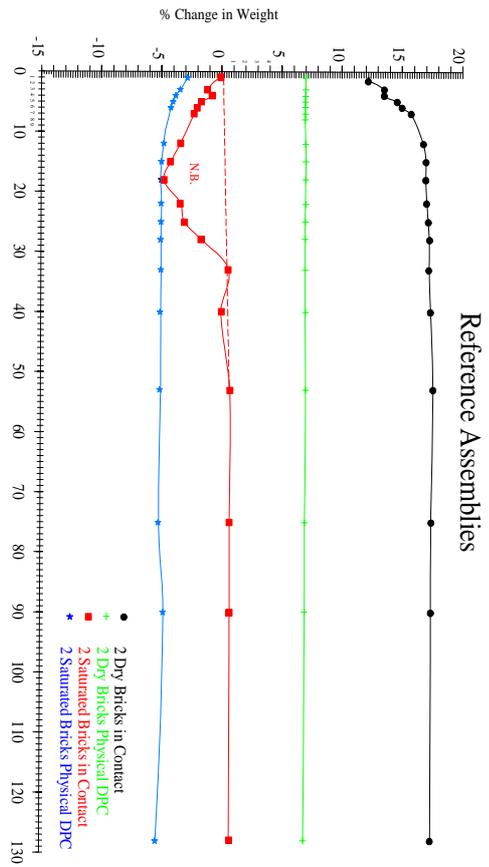
Graph 1 represents the water uptake of the reference assemblies:

- (a) when two dry bricks are separated by an absorbent paper tissue placed between the bricks, water is absorbed into the bottom brick across the paper tissue, to saturate the top brick. After about 20 days the water loss by evaporation from the assembly is equal to the water absorption from the tray and there was no change in the weigh of the assembly thereafter.

- (b) when two dry bricks are separated by a physical damp proof course (DPC) such as a piece of polythene, the immersed assembly quickly gains weight as the bottom brick becomes saturated but because no water can pass through the DPC thereafter, there is no further change in the weight of the assembly and the graph is again a straight line.

- (c) when two bricks separated by a paper tissue were pre-saturated and then places in the test trays, no substantial change was observed over the test period. The unexpected apparent drying out (N.B.), was discovered to be an unplanned draught which was isolated and blocked off from the test tray wherein the measurements settled down to the expected, i.e. no change in the weight of the assembly, demonstrating again that

the water evaporating in the brick assembly was equal to the water absorption and the bricks remind saturated.

- (d) when two saturated bricks were separated by a physical DPC the graph shows the top brick drying out demonstrating a loss in weight which settled to a steady state over the experimental period.

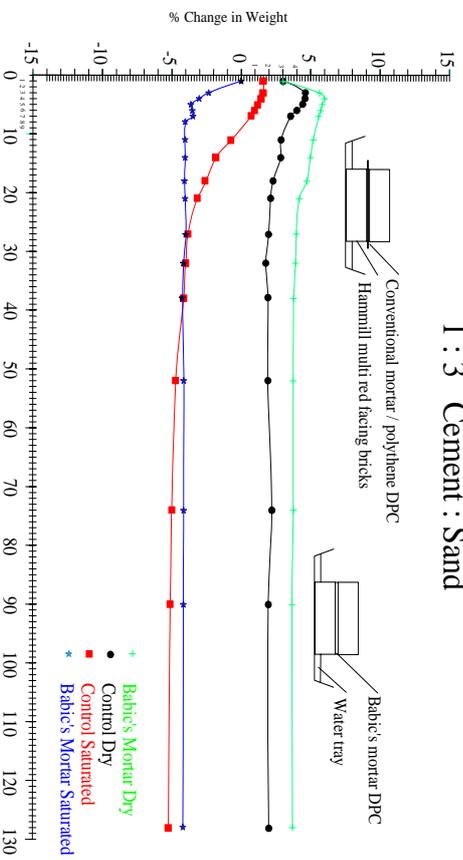
Graph 2 represents the water uptake of the 1: 3 portland cement and sand mortar:

- (a) The Babic's mortar dry assembly demonstrated a similar uptake but at a slightly higher level. The flat part of the graph demonstrates that there was no transfer of water across the chemical DPC and the steady state graph was lower than the polythene DPC, again due probably to the lower absorbancy of the bottom brick.

- (b) when the dry assembly with the conventional mortar layer between the two bricks was placed in the tray, there was an uptake of water which is reduced gradually so that by about the 28th day virtually no water was being transmitted through the mortar layer to the upper brick.

- (c) saturating the conventional mortar assembly initially retained water but the top brick dried out after about 28 days providing similar results to conventional DPC.

- (d) saturating the assembly with the Babic's mortar and placing into the water tray, was seen to be effective rapidly, achieving the drying out of the top brick more quickly than conventional mortar, indicating a lower transfer of water across the treated mortar layer. This assembly gave results very similar to the conventional polythene DPC

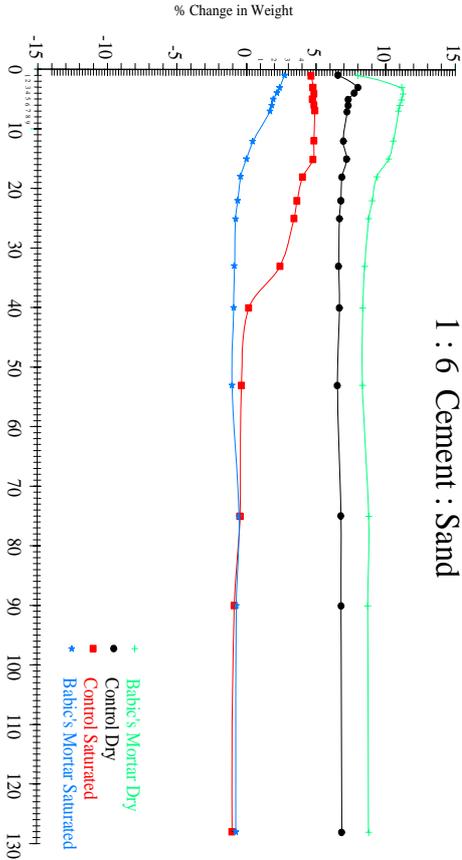
Graph 3 represents test using 1: 6 portland cement and sand mortar:

- (a) the dry Babic's mortar assembly, produced an uptake of water to give substantially the same trace as a conventional DPC but was slightly wetter than conventional DPC.
- (b) the dry control, conventional mortar using a dry assembly of bricks, indicates an uptake of water which dried slightly during the first 28 days, to give a constant trace to the end of the experiment.
- (c) the control assembly in a saturated condition demonstrated a gradual drying out after about 25 days to provide a steady state towards the end of the experimental period.
- (d) the experimental chemical DPC in a saturated state demonstrated similar behavior to the conventional DPC but was about 4% wetter and attained a similar final state to the saturated control.

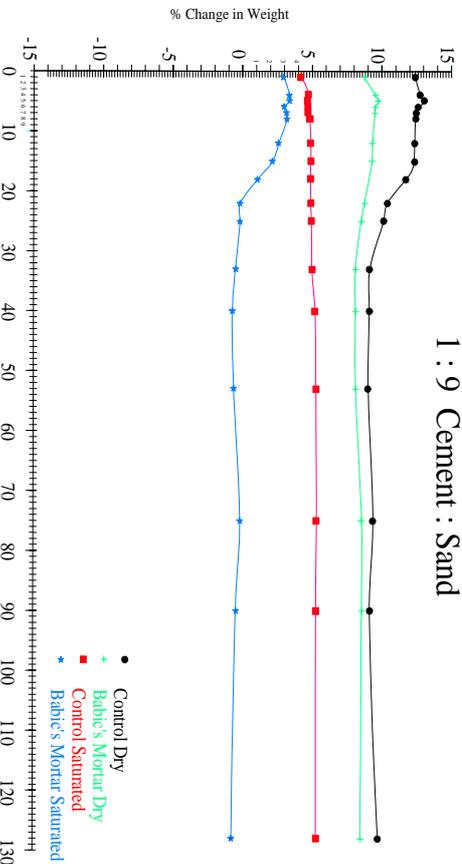
Graph 4 represents test using 1: 9 portland cement and sand mortar mix:

In this, an experimental mortar mix, we wanted to test the concept in an extreme situation. Certainly such mortars have no value in standard construction practice and the use of such mortar for structural purposes is inconceivable but it nevertheless remained a useful indicator of the effectiveness of the silicate molecule in this extremely porous and absorbent mortar:

- (a) initially the dry control demonstrated a large pick up of water which resulted in the top brick drying out by about the 20th day and thereafter leveled out at about 30 days, meaning that the top brick attained an equilibrium of water absorption and evaporation. The assembly was drawing water from the tray to remain wet for the duration of the experiment.

- (b) the saturated control showed a slight additional pickup of water transmitted from the tray to remain wet for the duration of the experiment again showing that the conventional 1:9 mortar mix transmitted water across the mortar layer.

- (c) adding the aqueous silicate to the 1: 9 cement sand mortar mix in the dry assembly resulted in the rapid uptake of water in the lower brick to allow only a small transfer across the chemical DPC into the top brick, which then dried out to achieve a steady state that resulted in the assembly being about 1% wetter than the conventional DPC assembly.

- (d) The Babic's mortar saturated assembly allowed the top brick in the water tray to dry out during the first 20 days to give a stable graph indicating that the mortar layer was acting as a DPC even though the trace did not fall to a value of 0 and was therefore not as effective as the polythene DPC.

Most usefully these experiments indicate that the 1:9 mortar mix with the chemical additive prevent the upward passage of water across the modified mortar layer. The conventional 1:9 mortar mix does not prevent the upward passage of water across the mortar layer and therefore the brick assembly remained wet.

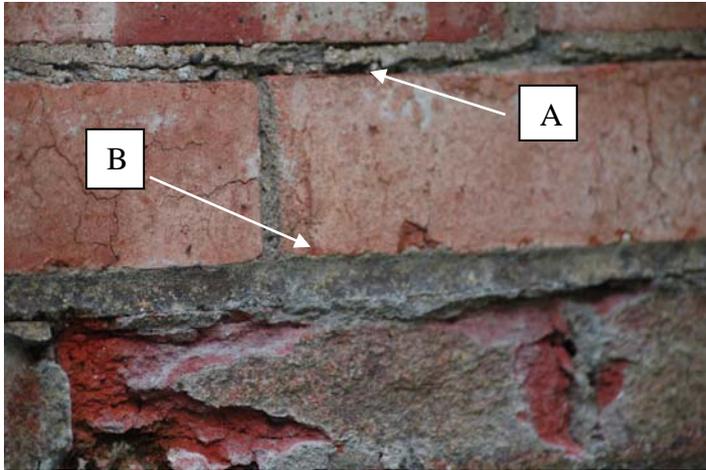
Fig 11

Example of conventional mortar "A" and chemical DPC mortar layer "B" after almost 25 years of exposure to British weather.

N.B. Spalling brick "C" August 2006.

Item "B" represents the water soluble aqueous silicate additive (the Rhone-Poulenc subsequently took over the manufacture of Rhodosil Silicate R 333 the aqueous solution of potassium methylsilicate<sup>3</sup>, 5% w/w preparation) to the mortar layer. The mix consisted of a 1:3 portland cement builders sand mixture which was separated into the conventional and experimental mortar piles, the same procedure that was used to prepare the cubes for the crushing tests, see Fig 10. To the conventional mortar "A" was added water and the mortar was mixed until the experienced bricklayer decided that the consistency was suitable for the given job. To the second portion of the above mixture, was added the R333 solution and mixed until the same workable consistency was achieved. The wall was built using the R333 mixture at the DPC level only and above that, was used the conventional mortar.

To this day the surface of the experimental mortar layer remains in an exceptionally good condition and in fact does not show any deterioration in the cementing matrix. Remarkably, the layer still shows the original brick layers finishing tooling marks as he closed off the surface. The regions of the layer that are bonded to the spalled brick "C" indicate that where there was spalling the bond between the mortar and the brick was so strong that the chemically modified mortar fractured, allowing the spalled section to fall away. That indicates that the treated mortar retains its structural strength and in fact retains sharp edges and continues to adhere to the brick either side of the mortar and spalled brick sections. At "A" the conventional mortar layer is seen to have responded to the weathering process and exhibits the typical long term deterioration seen in such materials.

The above astonishing finding indicates that cement bonded composites retain their structure without degradation for the nearly 25 year duration of this experimental follow up. There is every indication that no substantial change will occur in the immediate future so that if the water repellent characteristics of this mixture continue, then there will be no change in the nature of the treated mortar until the chemical structure of the formed aqueous silicate molecular lattice established during the curing process, starts to break down and the efficacy of the water repellence starts to abate. Normal degradation over the following 25 years or so is expected to occur and follow a similar degradation pattern to the conventional mortar layer as demonstrated at Item "A". That water is penetrating the wall below the DPC mortar layer is demonstrated by the fact that the bricks below the DPC are spalling, Item "C", so that the weathering process is clearly having a severe effect on the wet structure below but not above the DPC mortar layer.

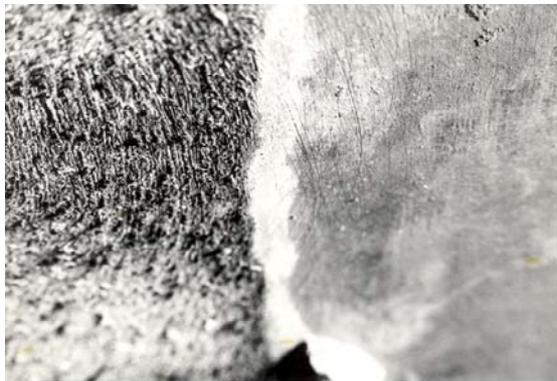
Fig 12

A single old asbestos cement roofing tile. On the left the area of tile exposed to the elements and on the right the area of tile covered by the overlapping tiles.

In retrospect, it becomes obvious as to what industry needs to do to contain fibre loss in cement fibre composites and with this in mind an old cement fibre roofing tile was examined and gave a rough sweep with a wire brush. Not surprisingly, the exposed surface resulted in deep gauge marks, asbestos flying out in a dusty plume whilst the

covered area of the same tile, barley showed scratches. This action demonstrated that the area of roofing tile that was covered by the overlapping tiles above it prevented wetting, so that the normal weathering mechanisms could not take effect. This excellent example of experimental controls, wherein the single tile, made by the same methodology, of the same batch composition and at the same time, acted as the best form of control to the wet and dry condition that the material was subjected to. This tile clearly demonstrated the effect of wetting one half of the product and exposing it to the weathering process, whilst keeping the other half of the tile dry. Embarrassingly obvious but the evidence was clear for all time and indeed demonstrates the outcome of reducing wetting, on cement fibre composites.
