## **REPORT ABOUT EXPERIENCES WITH CEMENT BASED CORRUGATED SHEETS VACUUM PROCESSING**

**SILVIO DELVASTO**

*Grupo de Materiales Compuestos, Escuela de Ingeniería de Materiales, Universidad del Valle, Cali,  
Colombia, [delvasto@univalle.edu.co](mailto:delvasto@univalle.edu.co)*

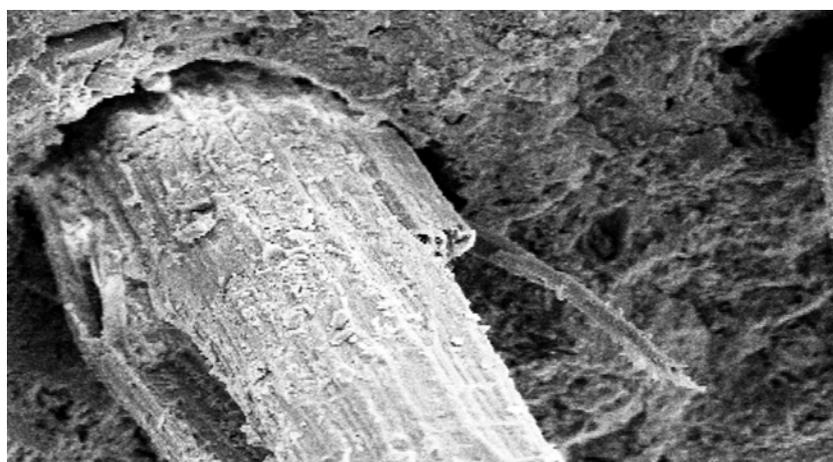
The fique fiber has been disposed in matrixes of concrete, mortar and paste of Portland cement. In some cases, cement has been blended with pozzolanic additions. The observation of the interface, as presented in Figure 2, shows a fique fiber being separated from the matrix. (Delvasto, 1998a). The fiber had pulled out of the matrix. The white particles adhered to the fiber had a Calcium to Silicon ratio of 4 as determined by energy dispersive x-ray spectrometry techniques. The fiber structure of the natural fiber seems to be undamaged and there is not indication of fiber failure after six months of normal curing. Between the fiber and the cement matrix there is a separation of approximately seven micrometers. This separation is produced probably by a process of swelling and shrinkage of the natural fiber during the first stage of mix setting and indicated that bonding between fiber and matrix was mainly due to mechanical interlocking. This gap is responsible for the low shear strength at the interface during the friction stage after the adhesion resistance has been overcome, as was proved in a pull-out study (Delvasto, 2004).

**Figure 2 - Fique fiber pulling out from the cement Portland matrix (200 magnifications).**

A natural fiber changes its dimensions when its humidity varies. This is explained by the fact that the polymers that compose its walls contain hydroxyls and other chemical groups with Oxygen that attracts the water throughout the hydrogen bonds (Rowell, 1998). The hemicelluloses are responsible for the water absorption, although other components also play an important role. The process of water absorption is correlated with expansion and shrinkage of the fiber. Shrinkage happens when the humidity of the fiber falls below the water level of saturation. This reversible process is deleterious for a natural fiber reinforced based Portland cement composite because the fiber separates from the matrix, as it was observed in Figure 2.
