DEVELOPMENT OF HYBRID FIBRE-CEMENT CORRUGATED SHEETS: A CASE STUDY OF EDGE CRACKS

ABSTRACT

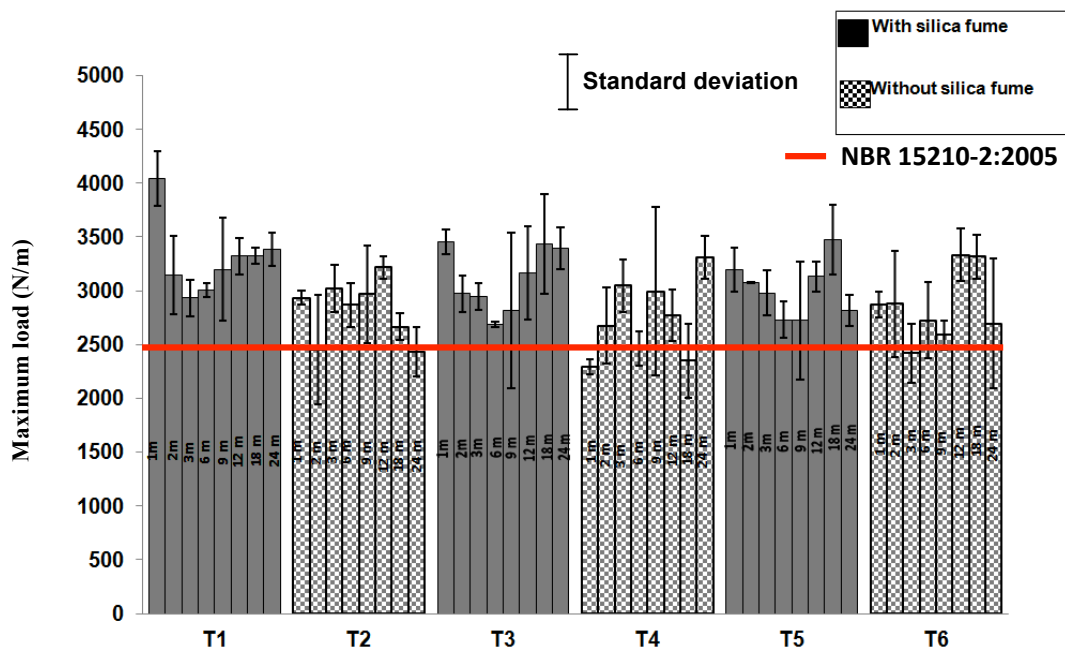
Figure 7 – Load per meter for different treatments and ages (*m: month).

Figure 7 shows average results and corresponding +/- standard deviation bars for the maximum load per meter of the hybrid fibre cements corrugated sheets (T1 to T6). The results of the maximum load indicate that no significant variations in the mechanical performance of the corrugated sheet for the T1 to T6 formulations over the 24 months of natural weathering exposure. Even with the increase in the amount of edge cracks in the north face of the pile sheet after 9 months of weather exposition, the mechanical performance of the corrugated sheets remains above 2500 N/m, according to the Brazilian Standards NBR 15210-2:2005 for roofing sheets with 5 mm of thickness.
